# Intel® Celeron® M Processor

## Specification Update

Document Number: 300303-007

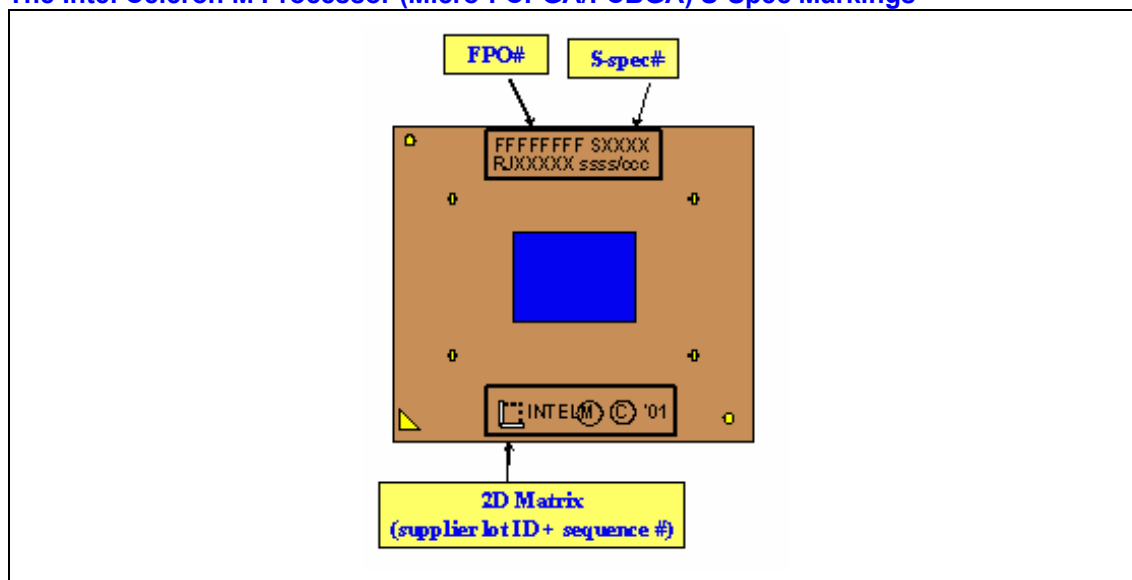
Figure 1. The Intel Celeron M Processor (Micro-FCPGA/FCBGA) S-Spec Markings

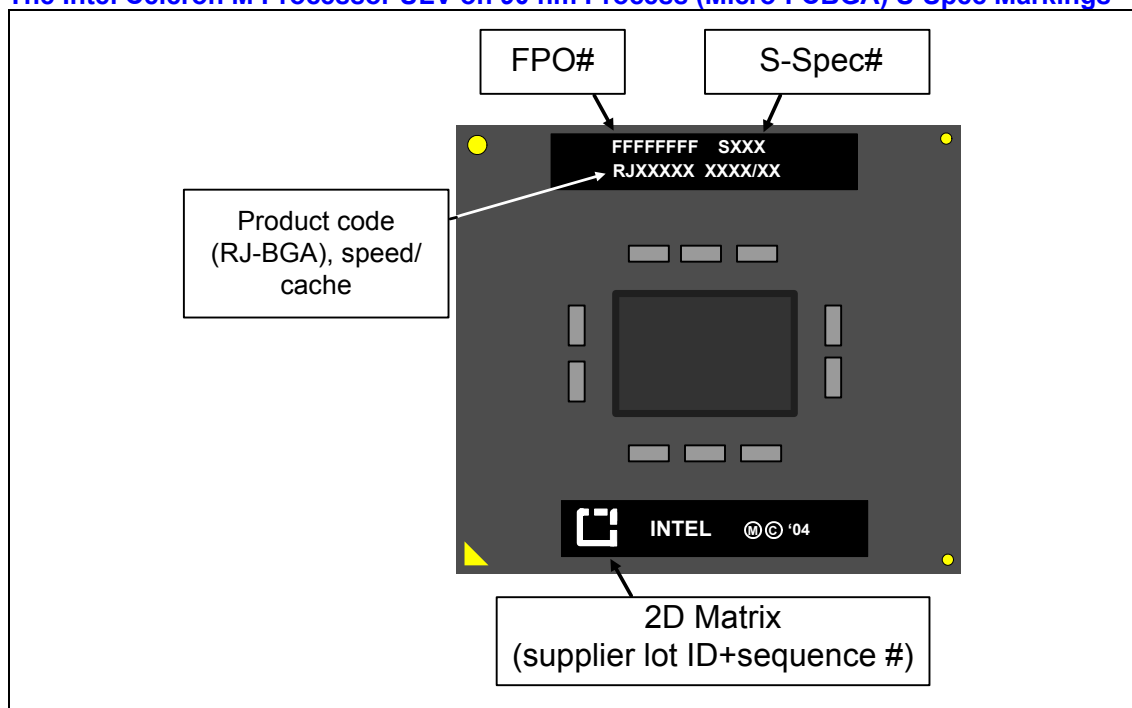
Figure 2. The Intel Celeron M Processor ULV on 90 nm Process (Micro-FCBGA) S-Spec Markings
